# Manhole Inspection Summary

Manhole # S11YY1009MH

**Location** Address: **5611 PIMILICO RD**

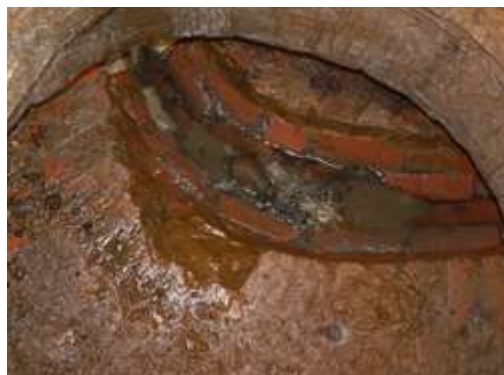
Top View

Bench deterioration. Evidence of surcharge - Bench debris. Channel debris.

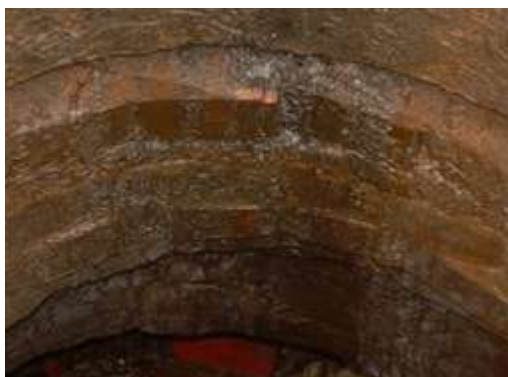
Defect

Frame leaks. Adjustment deterioration and infiltration.

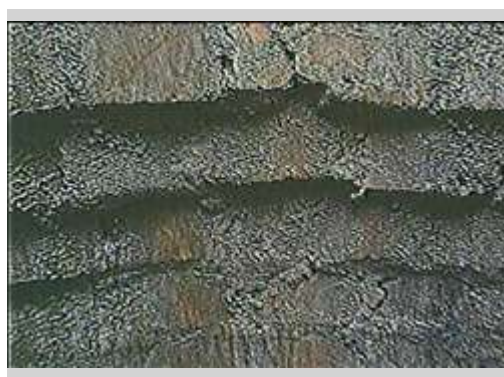
Defect

Corbel infiltration.

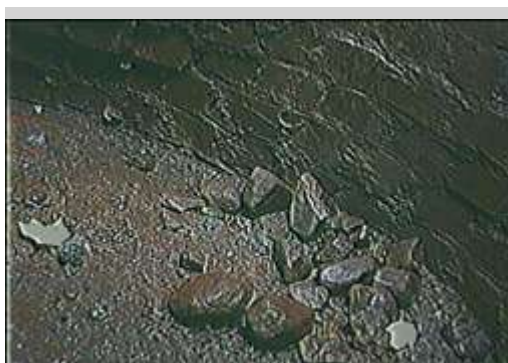
Defect

Barrel deterioration and infiltration.

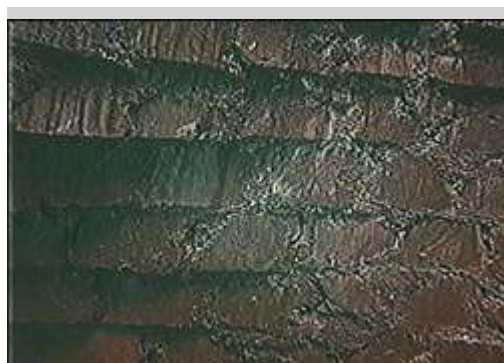
Defect

Barrel deterioration and infiltration.

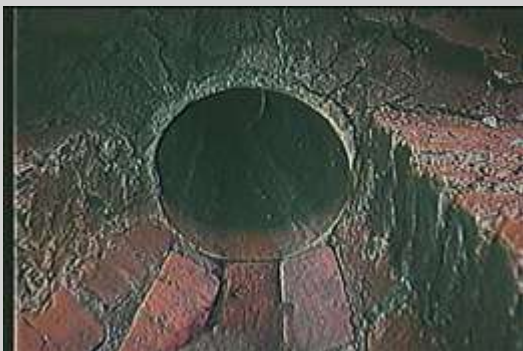
### 8 in. Circular Gravity Sewer Pipe In @ 3 O'Clock

Infiltration: **Evidence** Pipe Seal Cond: **Cracked**
